Variable Center of Gravity Lifting System

Design for Manufacturing, Reliability, and Economics Report

Team 5 (drs10f)
Devin Stubbs (csm11d)
Coert Maraist
Luke Leelum (lj110)
Yoel Bugin (yb12f)
Gabriel Omoniyi (goo14)

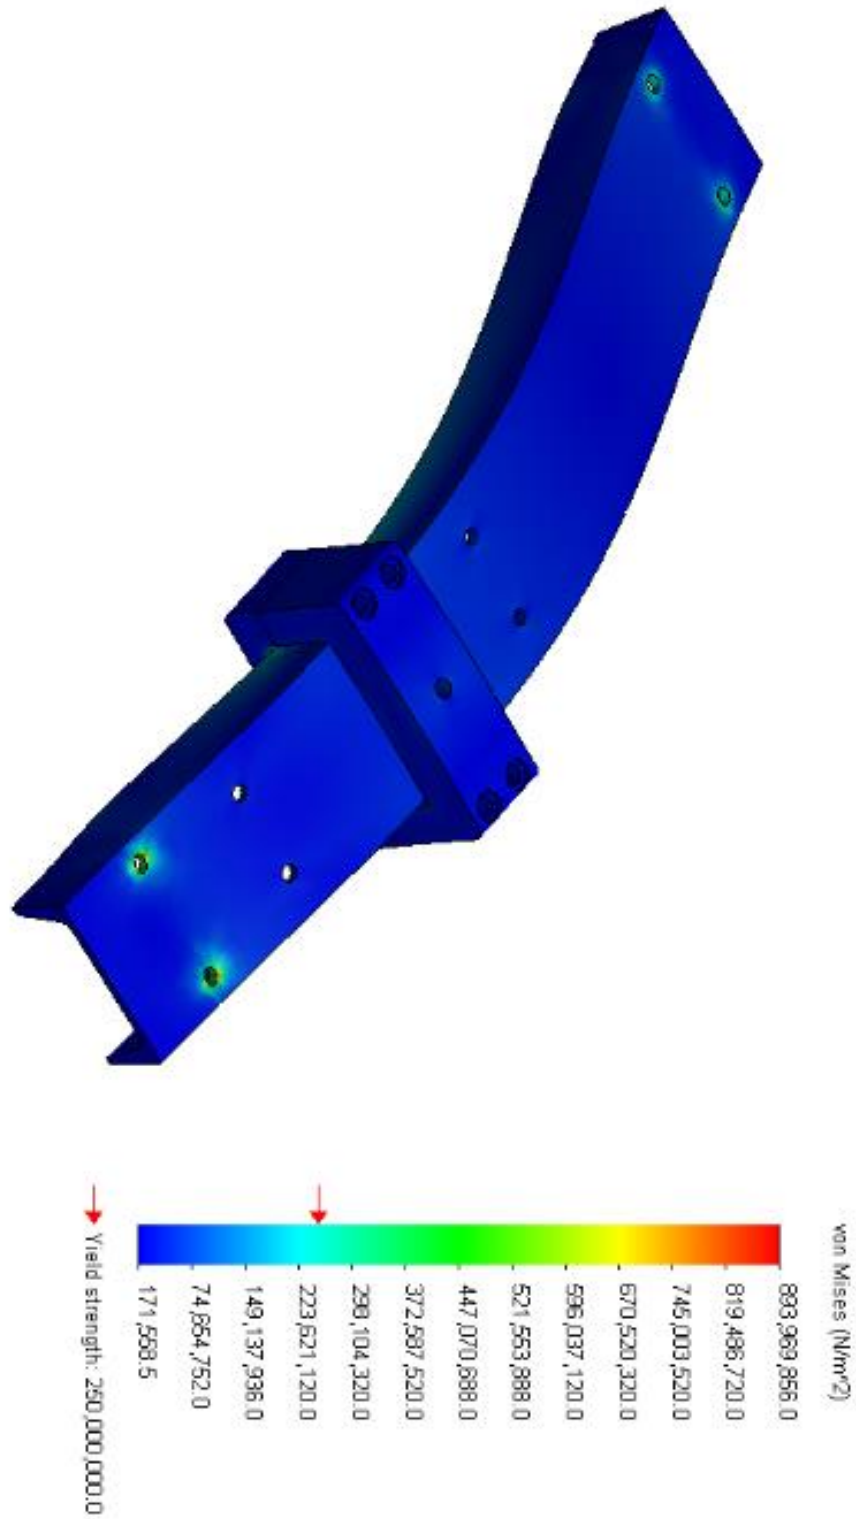
Figure 11 - Lifting Bar FEA
