Variable Center of Gravity Lifting System

Final Spring Report

Team 5

Team 5 Advisor:	Dr. Hollis
Submitted to:	Dr. Nikhil Gupta
Submission date:	April 10, 2015

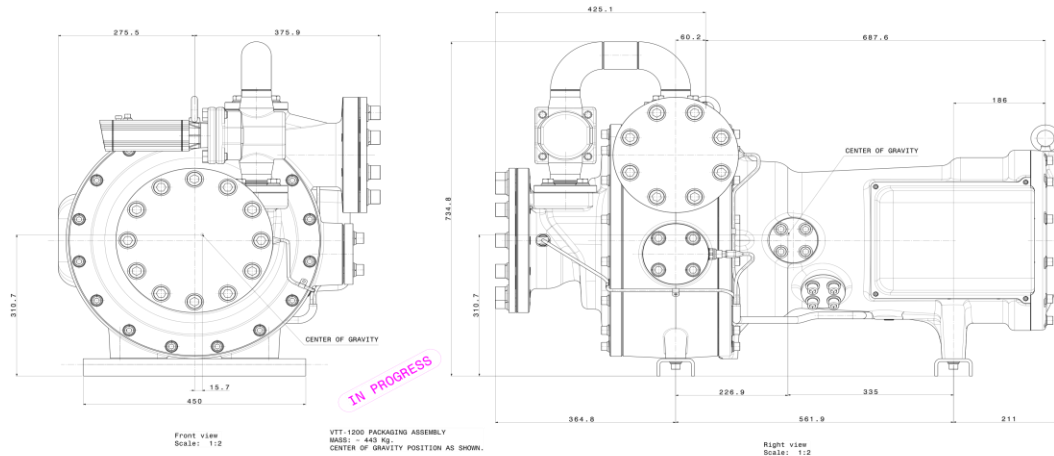
Figure 1 - Schematic of Turbocor's new VTT Compressor showing center of mass location

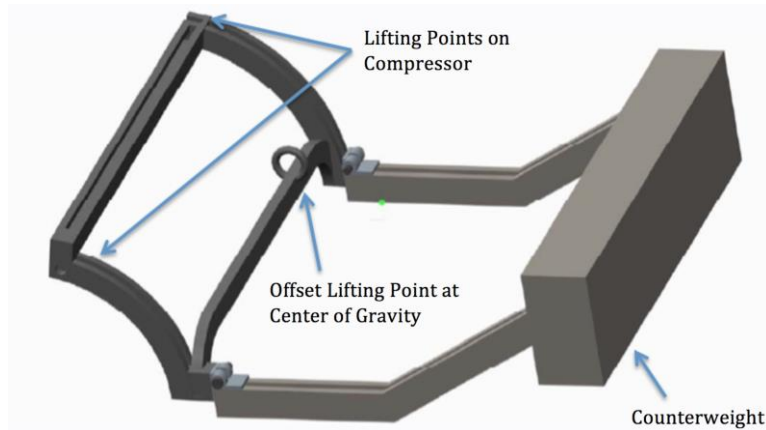
The initial goal of this project was to lift the compressor from a location that was offset vertically and horizontally from the two points of lift on the compressor. It did not take much analysis to realize this would result in a large moment caused by the center of gravity of the compressor. Thus, the concept of utilizing a counterweight in order to counterbalance the moment induced by the center of gravity of the compressor was introduced. Turbocor set a constraint of 500 lb. in total weight of the lifting bar. This meant that the distance of the point of lift to the center of gravity of the counterweight lifting bar had to be roughly twice that of the distance from the lifting point to the center of gravity of the compressor (~27.6 in.). A 3-D model of the counterweight lifting bar is shown below in Fig. 2.

Figure 2 - CAD Drawing of the Counterweight Lifting Bar Concept

When taking this design into consideration, team 5 made sure not to overlook the safety of the operator and the tight working conditions in the chiller rig. It would cause a hazardous working condition to have a 500 lb. counterweight extended at over two feet from a compressor that weighs a half ton. Additionally, there is sensitive and expensive equipment in the chiller rig. There is a large risk in damage if a 500 lb. counterweight were to swing around and collide with any of this sensitive equipment. The cost of the raw material had to be taken into account as well. In order to minimize the size of the counterweight, a very dense material would need to be used, such as tungsten, which would be very expensive with a scrap price of roughly \$20 per pound. [4] If the counterweight was to be made out of cheap steel, instead of Tungsten, in order to reduce cost, this would result in a much larger counterweight which could be detrimental for the tight working conditions. Furthermore, there was no clear solution as to how this lifting bar could be adjusted to account for a variation in center of gravity of the compressor being lifted.

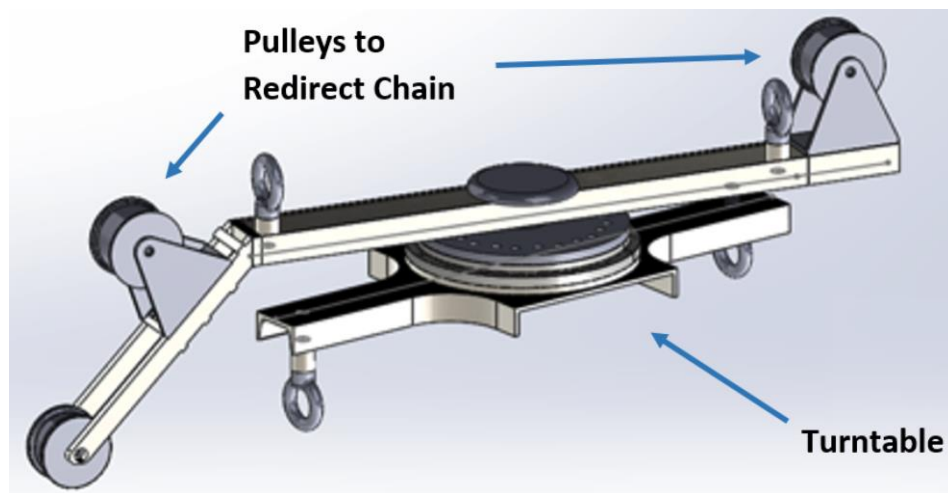
In addition to the counterweight design, team 5 devised a way to lift the compressor without the use of a counterweight. This design utilizes a cable and pulley system in order to increase the lifting height of the compressor, which is shown in Fig. 3. The higher pulley (on the right in Fig. 3) would redirect the cable to a fixed location on the gantry system and the lowest pulley (on the left in Fig. 3) would redirect the opposite end of the cable to the crane hoist. An issue with this design is the lack of rotation allowed by the lifting bar due to the fixed point of lift and so a turntable would be utilized for rotation of the compressor, which can be seen in the figure.

Figure 3 - CAD Drawing of the Two Points of Lift Concept

problem. For this design, the amount of moving parts and multiple pulleys concentrate points of possible failure and it was crucial that these components were engineered perfectly in order to prevent this. In addition to the safety concerns, there were concerns with the performance of the design. For one, this design requires a fixed point of lift on one side of the cable, requiring that one side of the lifting bar would be in a fixed horizontal location. The turntable is also subjected to torquing due to any alteration of the center of gravity of the compressor, which is completely unacceptable. In addition to the performance of the turntable, models that are rated for the loading this lifting bar will be subjected to are upwards of \$750, which is three-fourths of the budget.

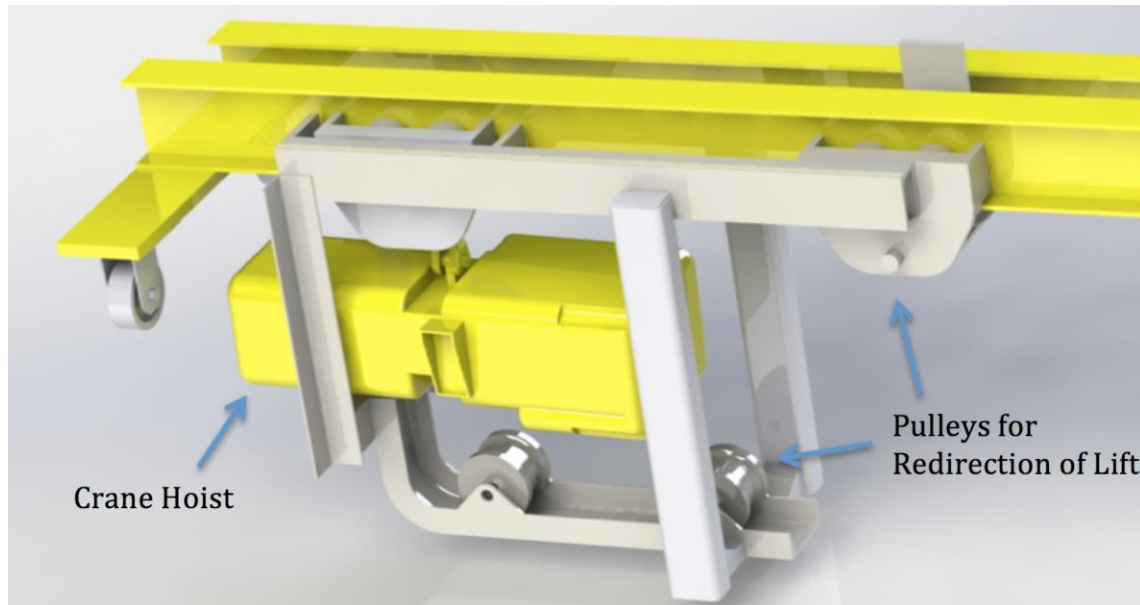
Figure 4 - CAD Drawing of the Redirection of Lift Concept

The team understood the true issue at hand was to be able to lift the new VTT compressor to a larger vertical distance and this could be achieved by redirecting the point of lift to a higher point than the crane hoist is capable of. This redirection of lift could be achieved by the use of a pulley system, which can be seen above in Fig. 4. The two lower pulleys would be used to redirect the chain horizontally away from the crane hoist, and the third pulley situated at the trolley on the right hand side would redirect the chain to a higher point.

Team 5 felt this design was a very strong candidate and could possibly be the solution that Turbocor is looking for. This redirection of lift is simple, effective, and came within the budget set by Turbocor. However, Team 5 ultimately rejected this design, for reasons following. This redirection of lift itself was affordable, but would require the design and manufacturing of a separate lifting bar that could adjust for a variation of center of gravity. This separate lifting bar would evidently reach beyond the scope of the budget. There is also a risk of failure concentrated at each pulley location due to the dynamic loading each pulley would experience. This design also required that a steel frame would be enclosing the crane hoist, as can be seen in the figure. This would cause a hazard for any personnel to hit their head while walking below the crane hoist. With the above points taken into consideration, team 5 collaborated to conceptualize a solution that had fewer drawbacks.

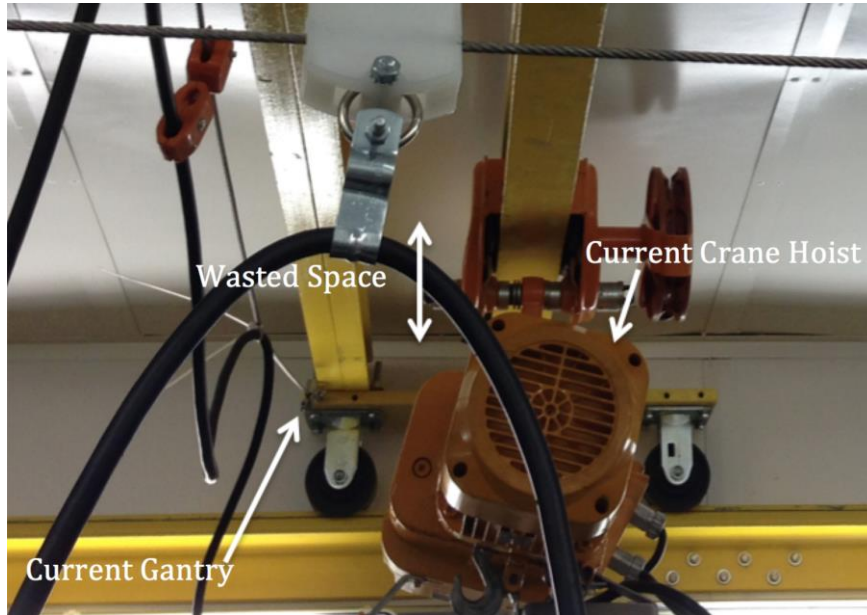
Figure 5 Picture of the current gantry and crane hoist

In Fig. 5 above, the current crane hoist is suspended below one of the I-beams and there is a substantial gap between the top of the hoist and bottom of the I-beam. Consequently, there is a large amount of wasted space between the hook of the crane hoist and the bottom of the I-beam. This led team 5 to the solution of increasing the crane hoist height to increase the overall lifting height of the compressor. The conceptual model of this solution is shown above in Figure 6. Drawings for the lifting bar and gantry system can also found in APPENDIX C -

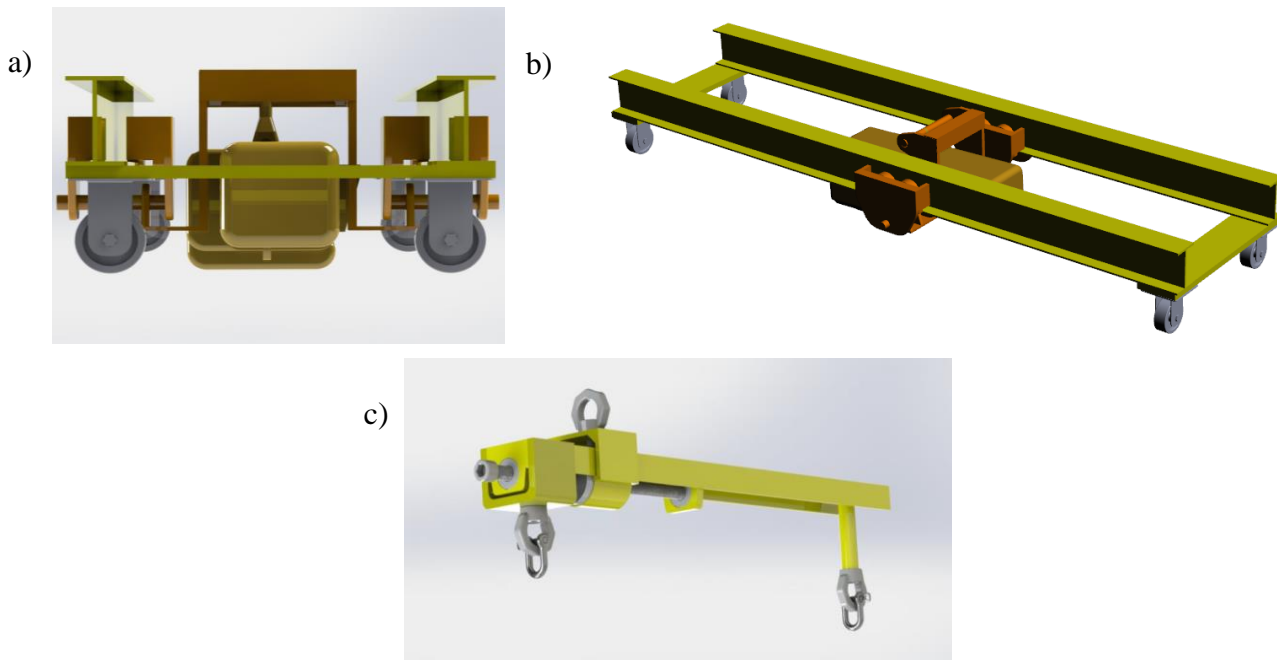
Figure 6 (a) Front view of the CAD drawing (left), (b) dynamic perspective showing the components of the trolley system (right), (c) dynamic view of lifting bar (bottom).

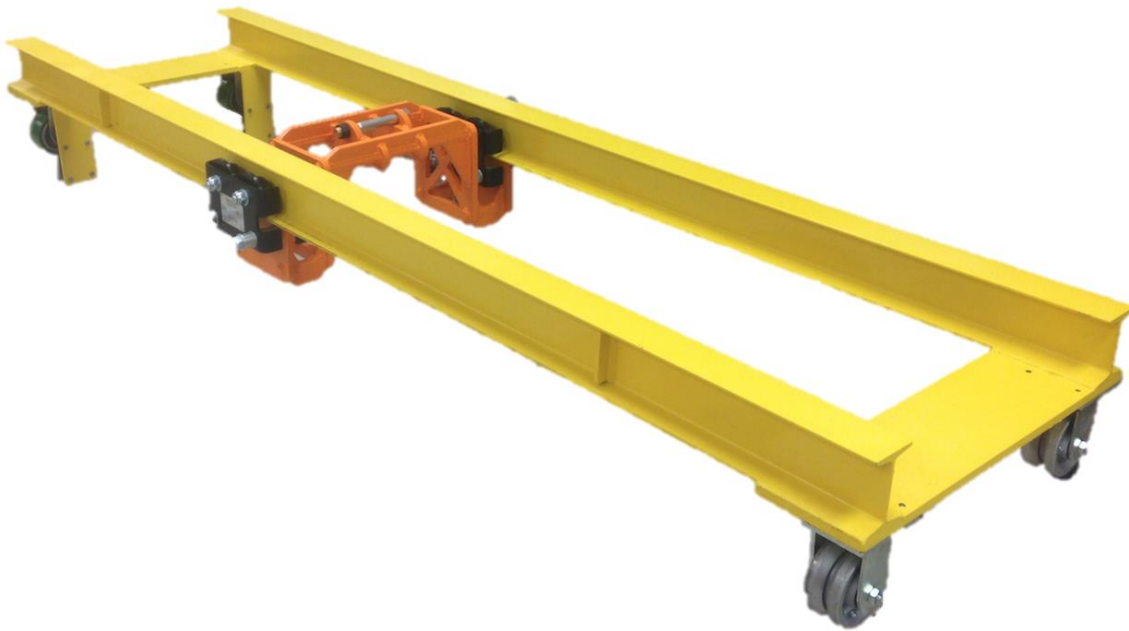
The Redesigned Gantry along with the newly designed Lifting Bar was declared as the final design to solve Turbocor's problem by adding approximately 8" of lifting height to the system. The increase in vertical height from the current system can clearly be seen in Fig.7 below. The redesigned gantry required the I-beams to be spread apart with enough space so that the hoist could be suspended between them and the implementation of a custom trolley. Additionally it was designed to maintain the original gantry dimensions to avoid any complications that may come about when implementing and testing the system in chiller 3 rig. Team 5 was also able to use smaller I-beams than the ones utilized on the original gantry which saved time during fabrication, avoiding the need to shave off parts of the I-beam. This was due to the small constraints and the sloped ceiling, with the center of the room being the highest point and the lowest point where the ceiling met the walls.

Figure 7 Picture of the painted and fully assembly gantry and trolley system

A necessary component of this design was the need for a redesigned trolley system that could suspend the crane hoist between the two I-beams, which can be viewed in Figure 7. At this point in the design process, Team 5 has gone through several revisions of this redesigned trolley. However, the visual representation in Fig. 9 is the final design of the trolley. Team 5 was aware of the immense stresses that the trolley will endure and so the materials chosen and their dimensions was of the utmost importance. Also, it was imperative that the trolley remained square on the gantry system while in operation. The low overhead clearance above the gantry system due to the ceiling of the chiller room was also very important when designing this trolley. It was crucial that the trolley and/or crane hoist never come into contact with the ceiling, and so a compact trolley design will be the most effective.

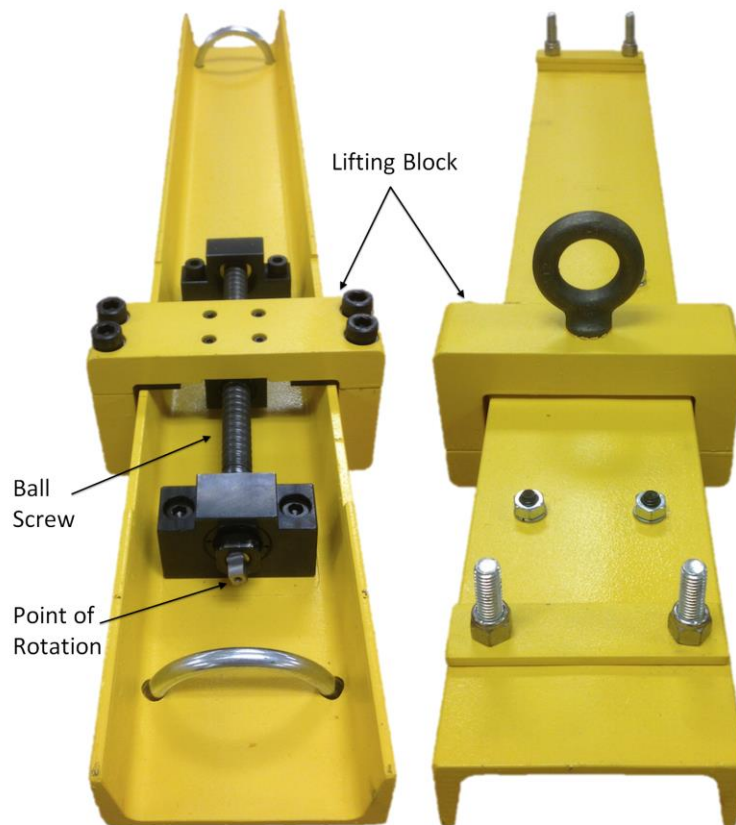
The lifting bar was essentially designed from the current lifting bar being used by Turbocor, with the exception of the variable point of lift for a variation of center of gravity. The power screw, located inside the C-channel of the lifting bar, is used to translate the lifting hook along the axis of the lifting bar and will be adjusted manually. The point of lift, represented by the U-bolts assembly, was designed in such a way that the load of the compressor is felt by the C-channel itself and not by the power screw. The bearings ensured ease of movement of the power screw and also supported the load of the compressor as to relieve any loading on the power screw itself. The final lifting bar design can be view in Fig. 8 below.

Figure 8 Picture of the painted and fully assembly lifting bar

Due to the moving parts of this lifting bar, it was crucial that Team 5 designed the bar with the upmost engineering practices. It was imperative that the power screw experienced only axial loading and that the bearings between the lifting assembly and the C-channel were rated for the proper amount of loading. All components that were purchased from a vendor had a Factor of Safety (F.S.) of at least 1.5 for the load experienced by the lifting bar. Any components that are

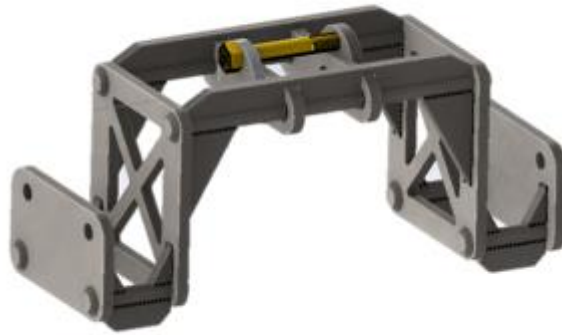
Figure 9 Final trolley design

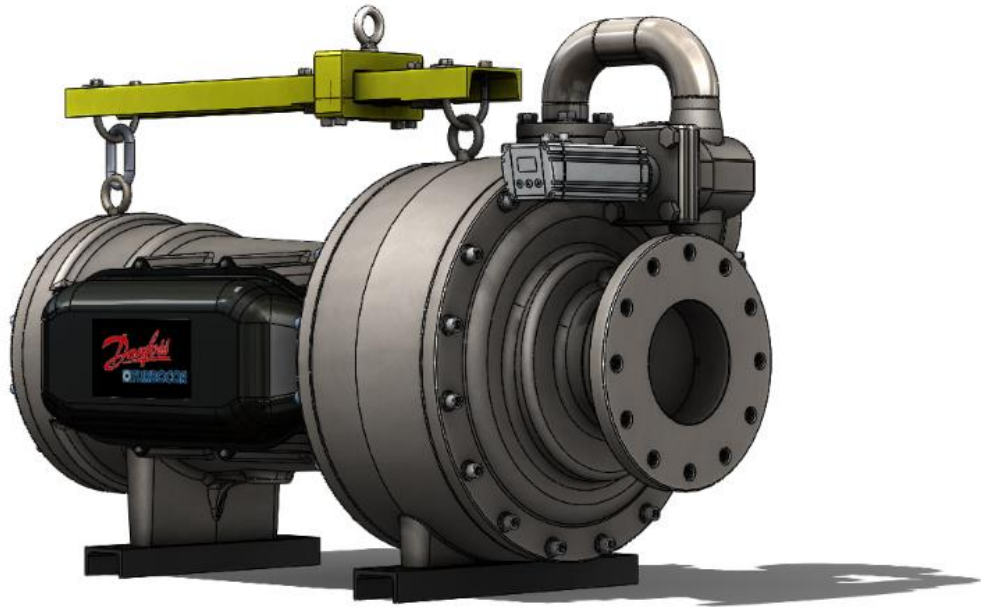
Shown below in Fig.10 and Fig. 11 is the finalized completed assembly of each component that was prototyped in spring. The only two components that Team 5 will not be responsible for procuring and manufacturing, is the compressor and the crane hoist (both are in the figure). With just the gantry system alone, team 5 saved about 6 in. of vertical distance. The Lifting bar has also received a height reduction, saving 2 in. The combination of this system saves approximately 8 in., which is sufficient to lift the compressor to the required height.

Figure 10 VTT compressor and adjustable lifting bar

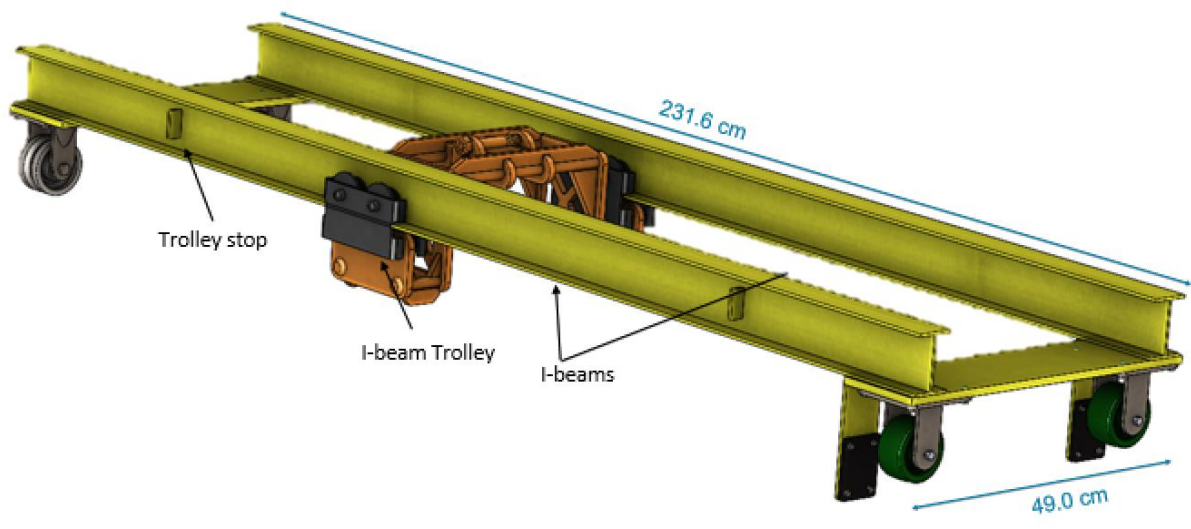
Figure 11 CAD model of gantry and trolley

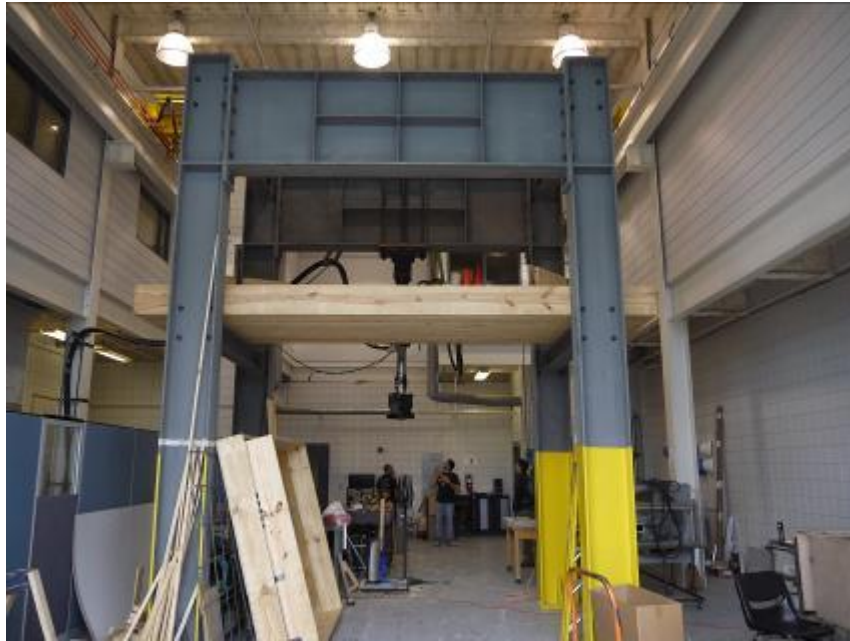
Team 5 was able to utilize the Structures Lab in the civil engineering department at the FAMU/FSU College of engineering in order to perform prototype testing. This lab houses an MTS actuating hammer that can apply forces up to 110 kip, in both tension and compression. The figure below shows the MTS actuator mounted on a MTS 55 kip Material Testing Frame.

Figure 12 MTS actuator in the civil engineering Structures Lab

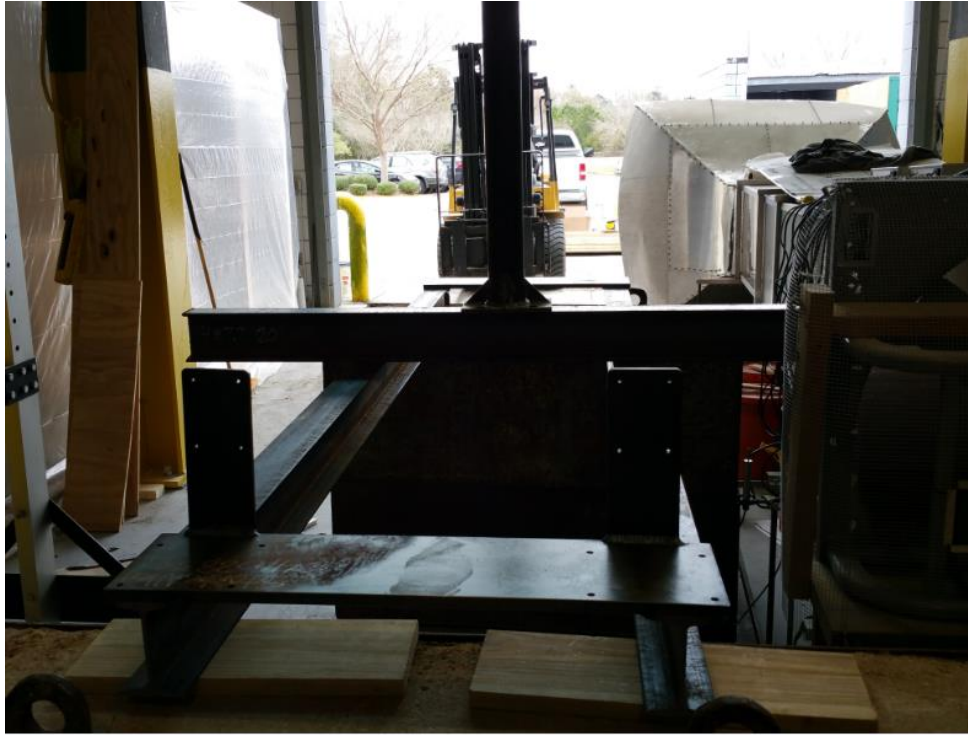
The initial testing of the variable center of gravity lifting system took place in the strength of materials laboratory on February 12 under the supervision of Brandon Winters. Rearranging the lab took several hours to ensure that the testing closely simulated the environment in chiller 3. The gantry was set up directly under the actuator and was subjected to 2500lb force. It performed well under the 2500lb load test, experiencing roughly 1 mm of deflection which closely match the FEA simulation results of 0.5 mm and this can be seen in the figure below.

Figure 13 Gantry load testing (Experiencing 2500 lbf load)

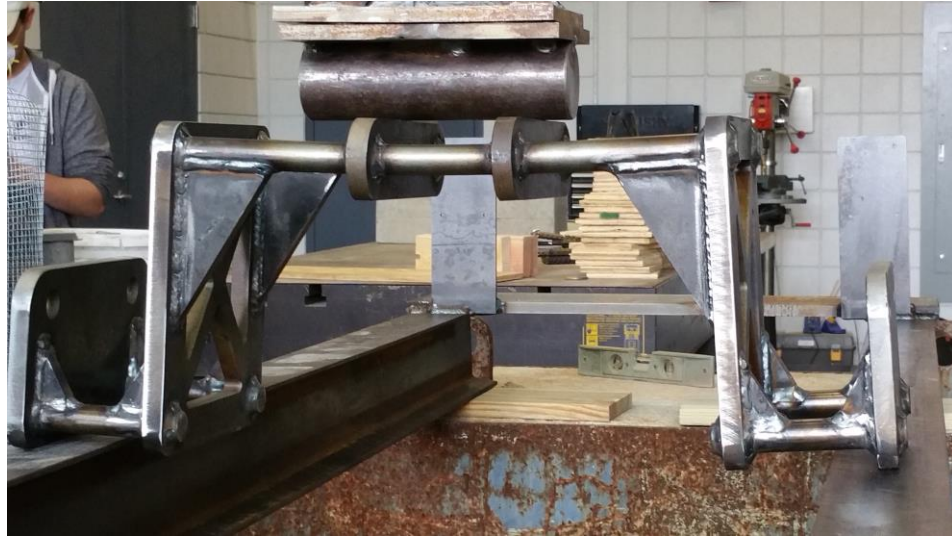
The trolley was placed on top of the gantry and in the same fashion as gantry and was also subjected to 2500lbf. However unlike the gantry the trolley showed signs of plastic deformation undergoing roughly 8 mm of deflection. This was not expected because the initial FEA analysis displaying approximately 1 mm of deflection and was result of testing oversight. One cause was due to the fact that the trolley was placed stationary on top of the gantry instead of hanging from trolley below the I beams which caused the trolley to experience a large amount of deflection. In the Fig. 14 below the deflection experienced by the trolley can clearly be seen. Another reason the testing does not match the FEA analysis is because of the idealized simulation and limited constraints in the modeling program. Any slight change in constraints and model properties would drastically change the results or cause the simulation to fail. After presenting the results and gaining feedback from Turbocor, Team 5 decided to revise the trolley by adding supplementary gussets to the frame in efforts to reduce deflection. Additionally several new FEA simulation were performed in order to best match the results to real life application. Currently Team 5 is still in the process of performing a second round of testing to the revamped trolley with the gantry in order to gain more accurate results and also set begin initial testing on the lifting bar to complete the project.

Figure 14 Magnified View of trolley load testing (Experiencing 2500 lbf load)

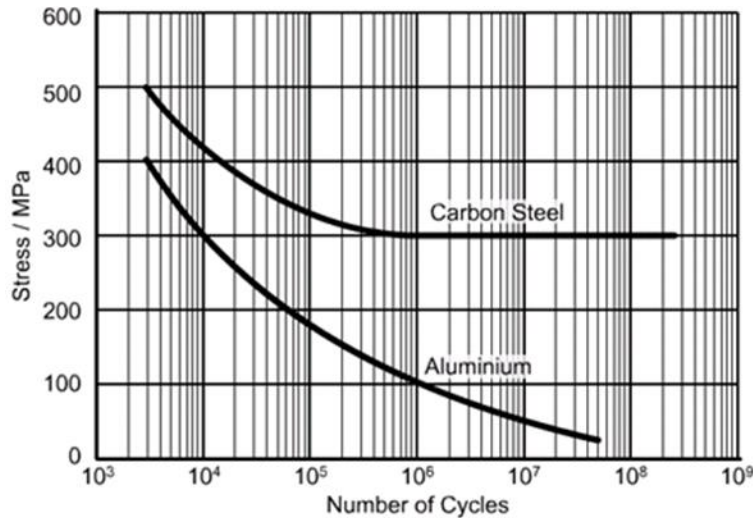
To determine how this device will perform over time, it is necessary to compare the stresses felt by the system to a fatigue curve for steels. The maximum stress that the system will feel is approximately 70 MPa. This system will not cross the endurance limit since it approaches nowhere near the stress needed to cross the endurance limit. Anything under the endurance limit has infinite cycles. Shown below is the fatigue curve of aluminum and steel.

Figure 15 Fatigue Limit of Steel

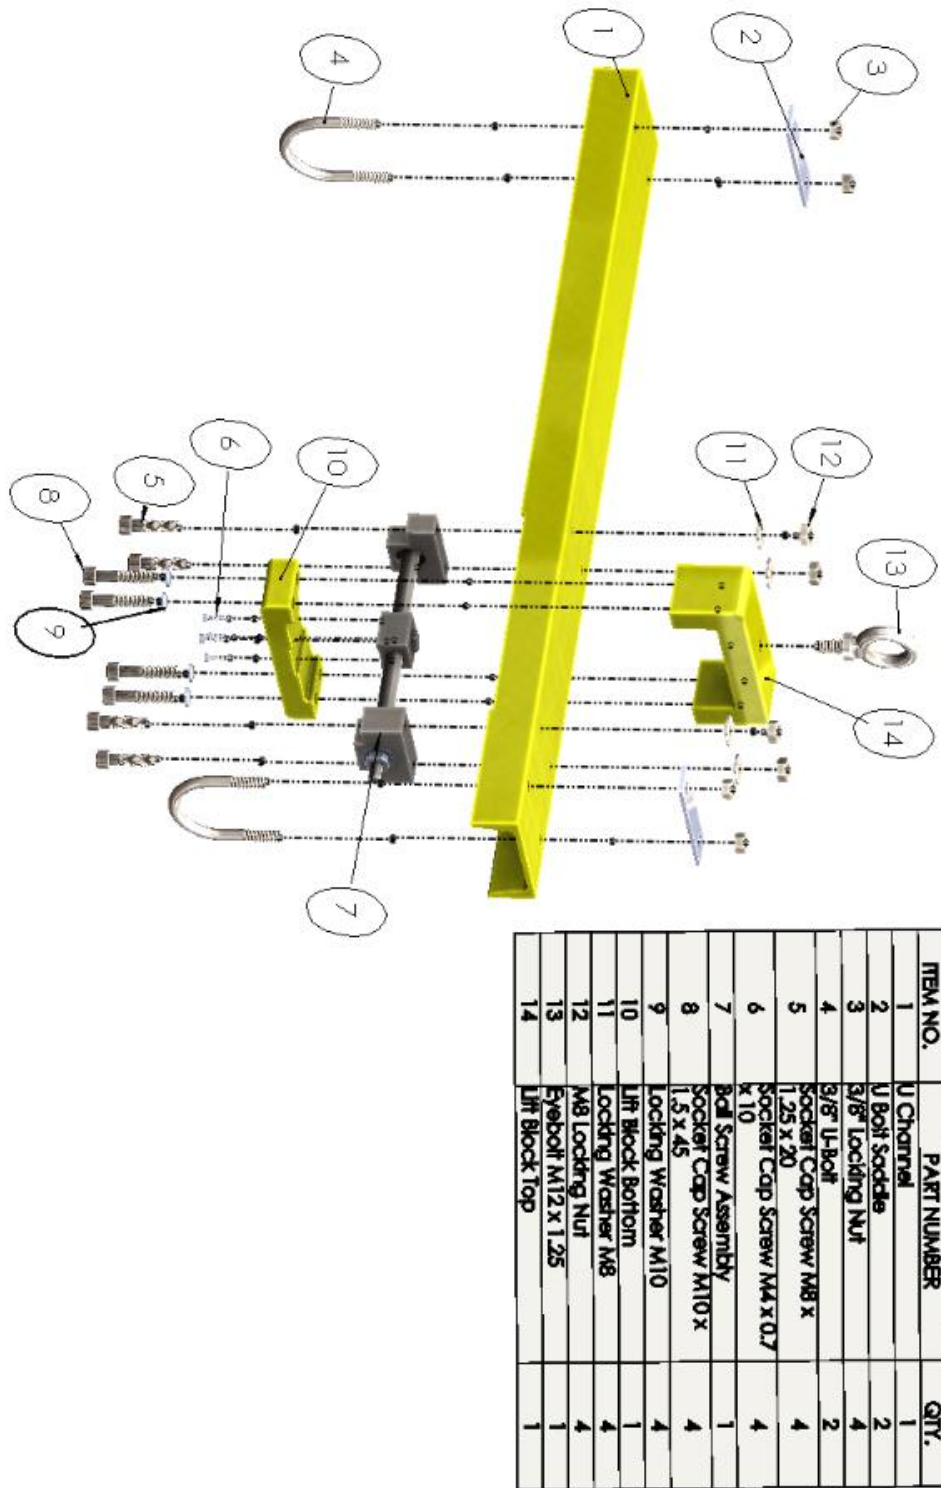
Figure 18 - Lifting Bar Exploded View

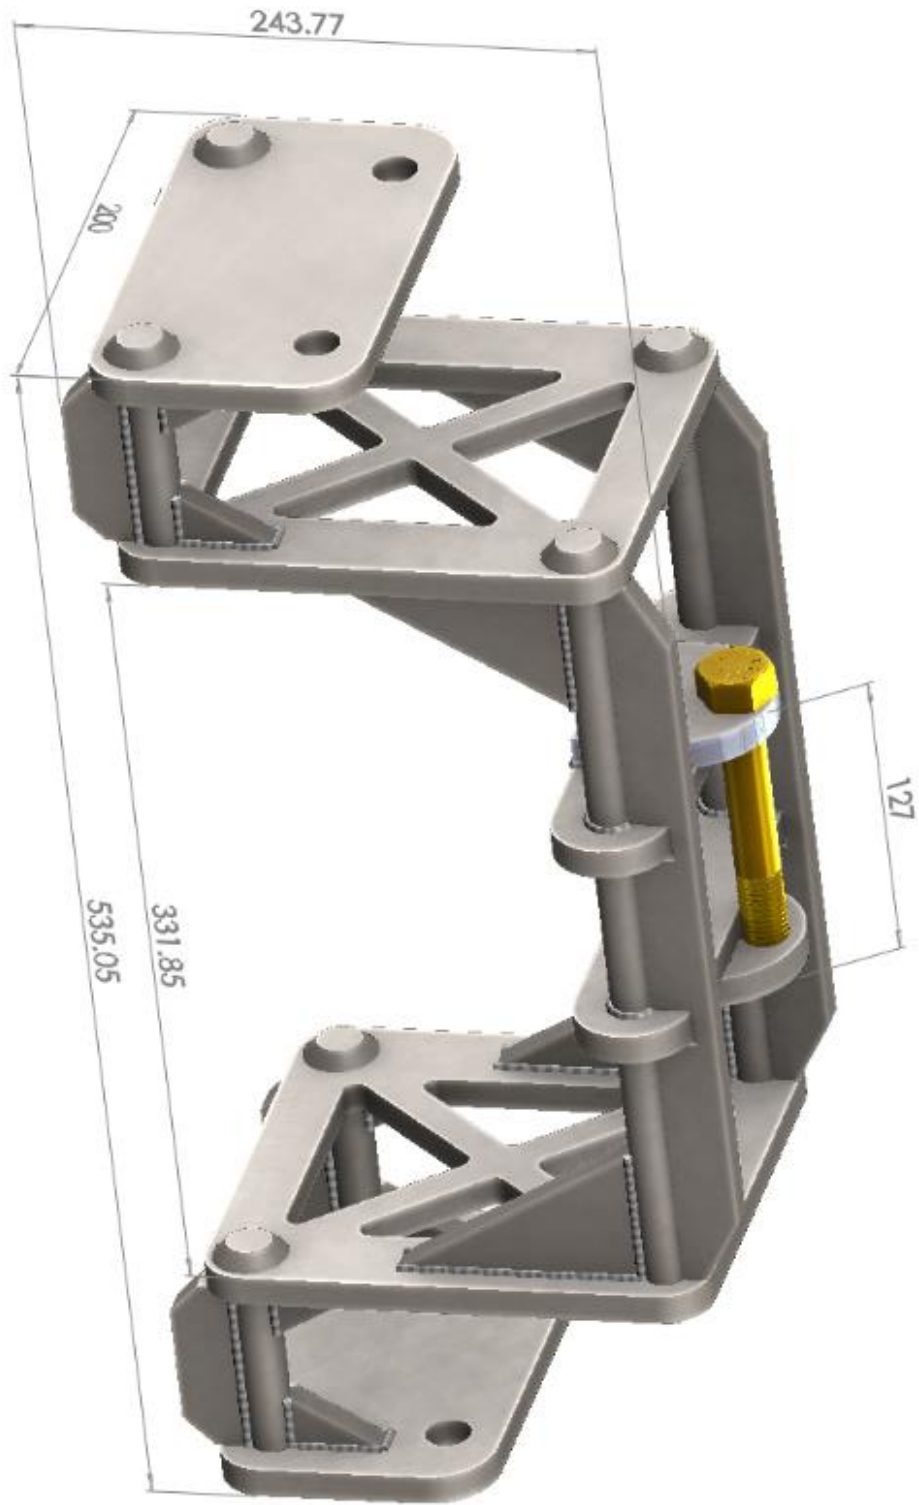
Figure 20 Assembly of Trolley

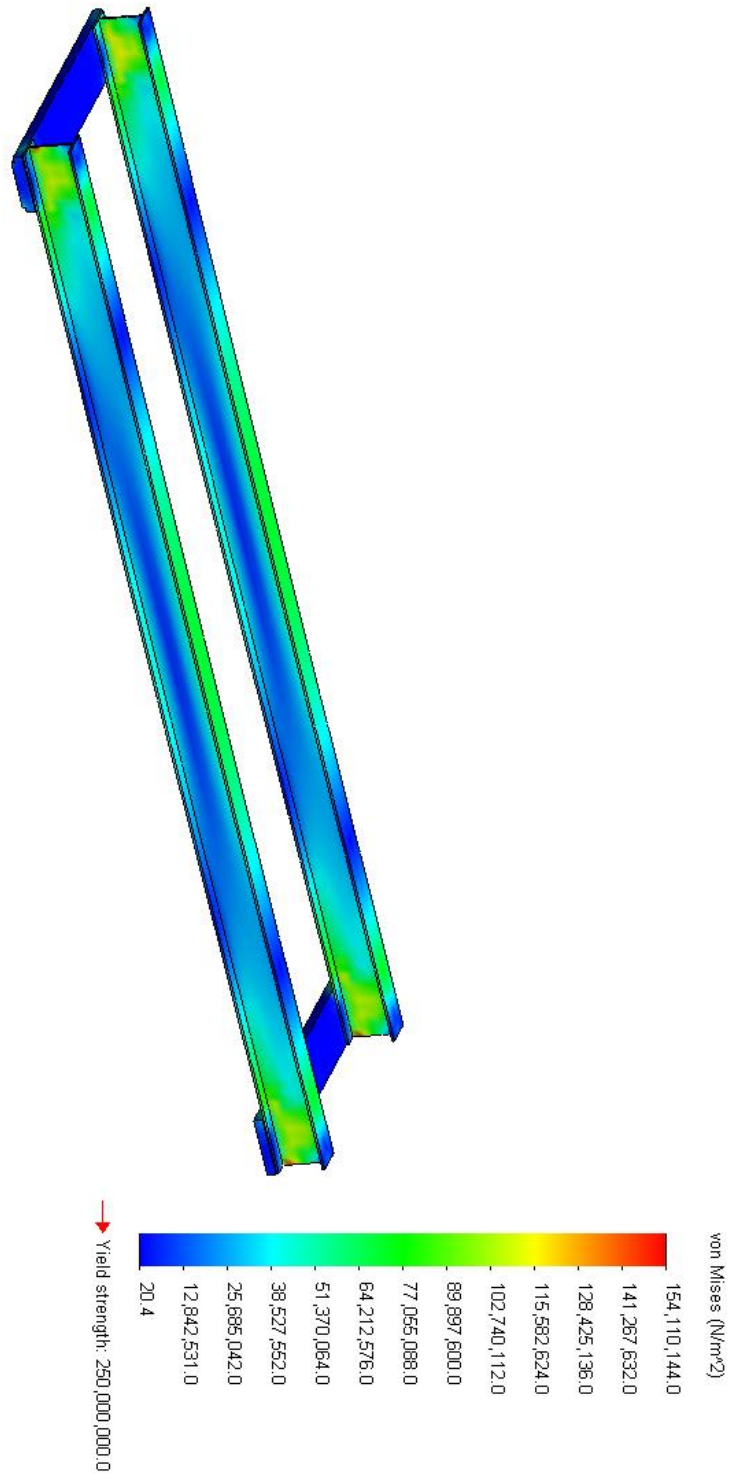
Figure 21 Gantry FEA

Fig. 21 APPENDIX B - FEA is a visual representation of how the I-beams would react under the immense loading. The center of the I-beam is where the trolley system would be applying a maximum stress on the beam considering it is at the center of the beam and furthest from either support location. The color spectrum depicts the range of stresses experienced by the beam (red being the most and violet being zero). With a safety factor of 1.25 applied to the loads, it can be seen that the beams are not stressed to plastic deformation at A36 Steel's yield strength of 36,259 psi (250MPA). This analysis shows that the redesigned gantry does not come close to experiencing plastic deformation, proving that this particular design is a viable solution.

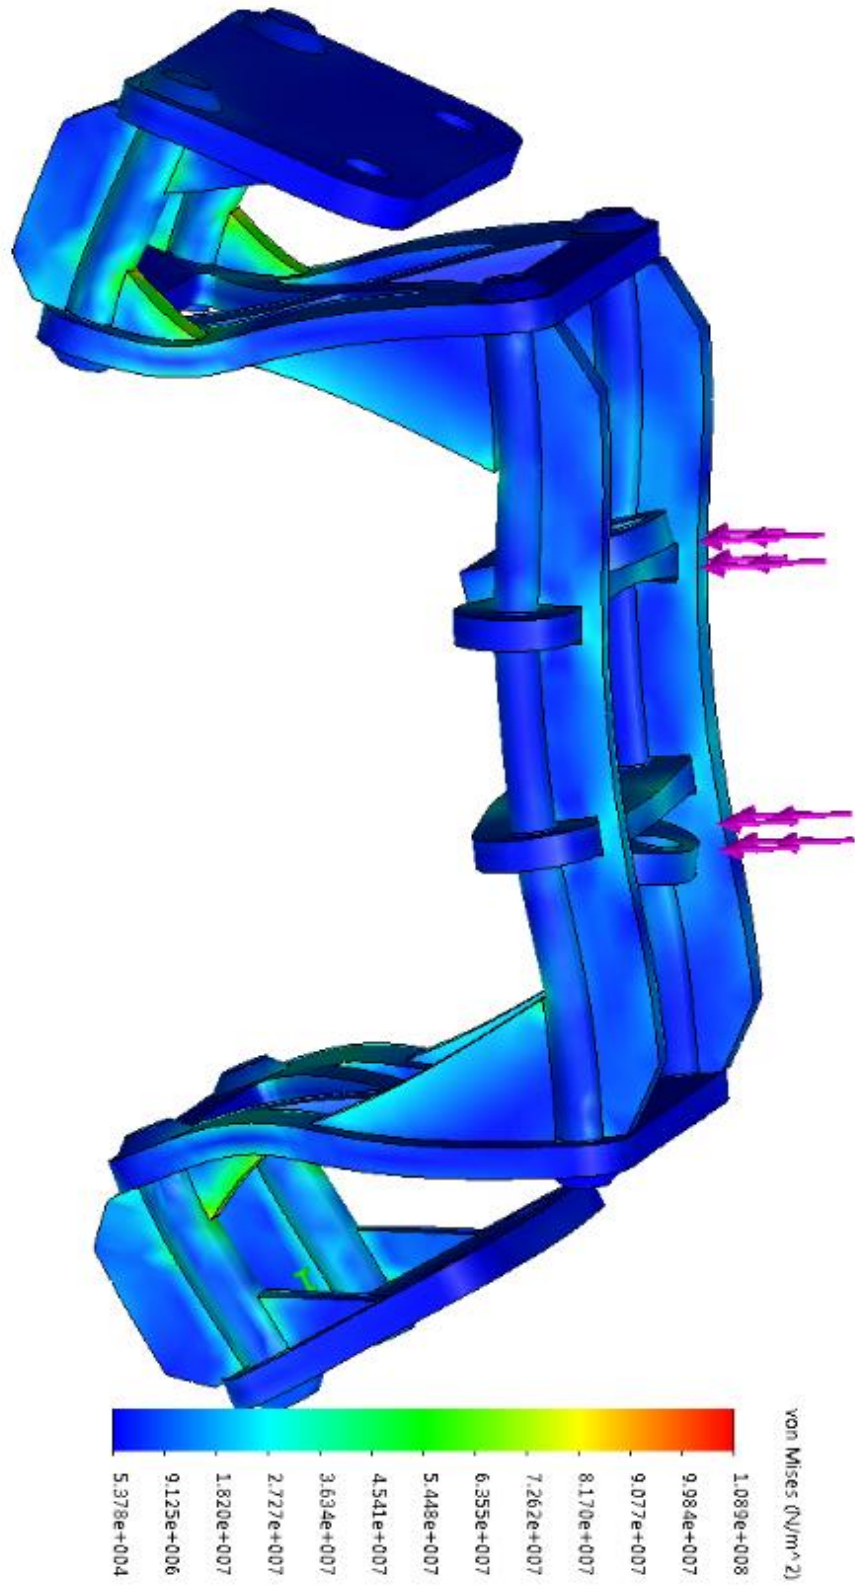
Figure 22 Trolley FEA

Shown in Fig. 22 APPENDIX B - FEA below is the load analysis data on the final version of the trolley system. The greatest challenge of designing this component is the very large deflection that occurs in the center of the trolley due to the hoist, lifting bar, and VTT compressor being hung on a hook in the very center of this bar. To mitigate this, gussets have been added to increase the surface area of material and improve the geometry of the trolley for increased strength. In this analysis, it can be seen that the maximum stress felt by this trolley is under the A36 Steel yield strength of 36,259 psi (250MPA), proving this design is a safe solution even with a safety factor of 1.25.
