Electric Vehicle Optimization Team 2

Goal Statement:

- “To increase the current range and operable conditions of the electric vehicle by utilizing a secondary power source in efforts to apply this to semi-trucks.”

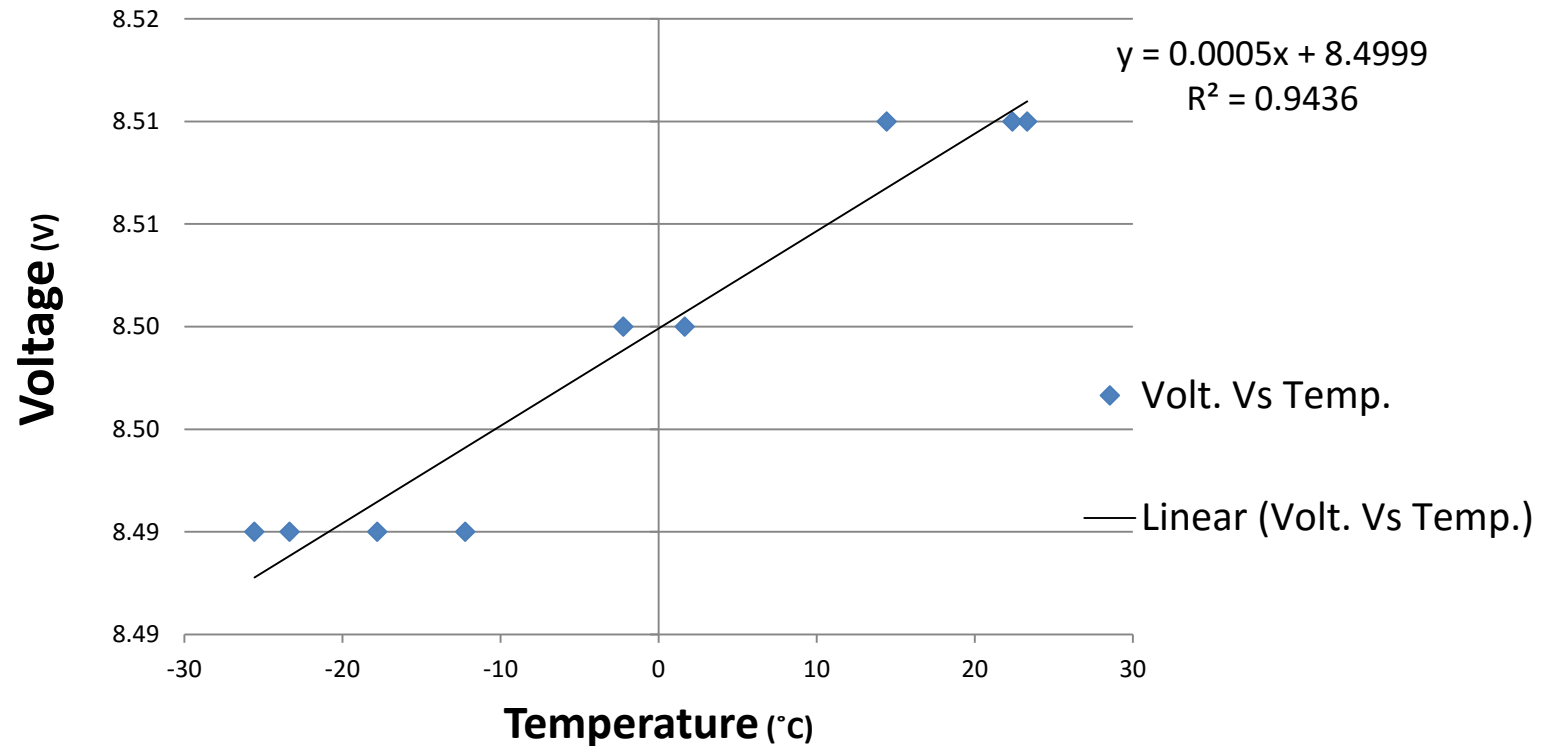
Voltage vs. Temperature Relationship

Figure X: Plot of the measured voltage of a charged battery at corresponding temperatures

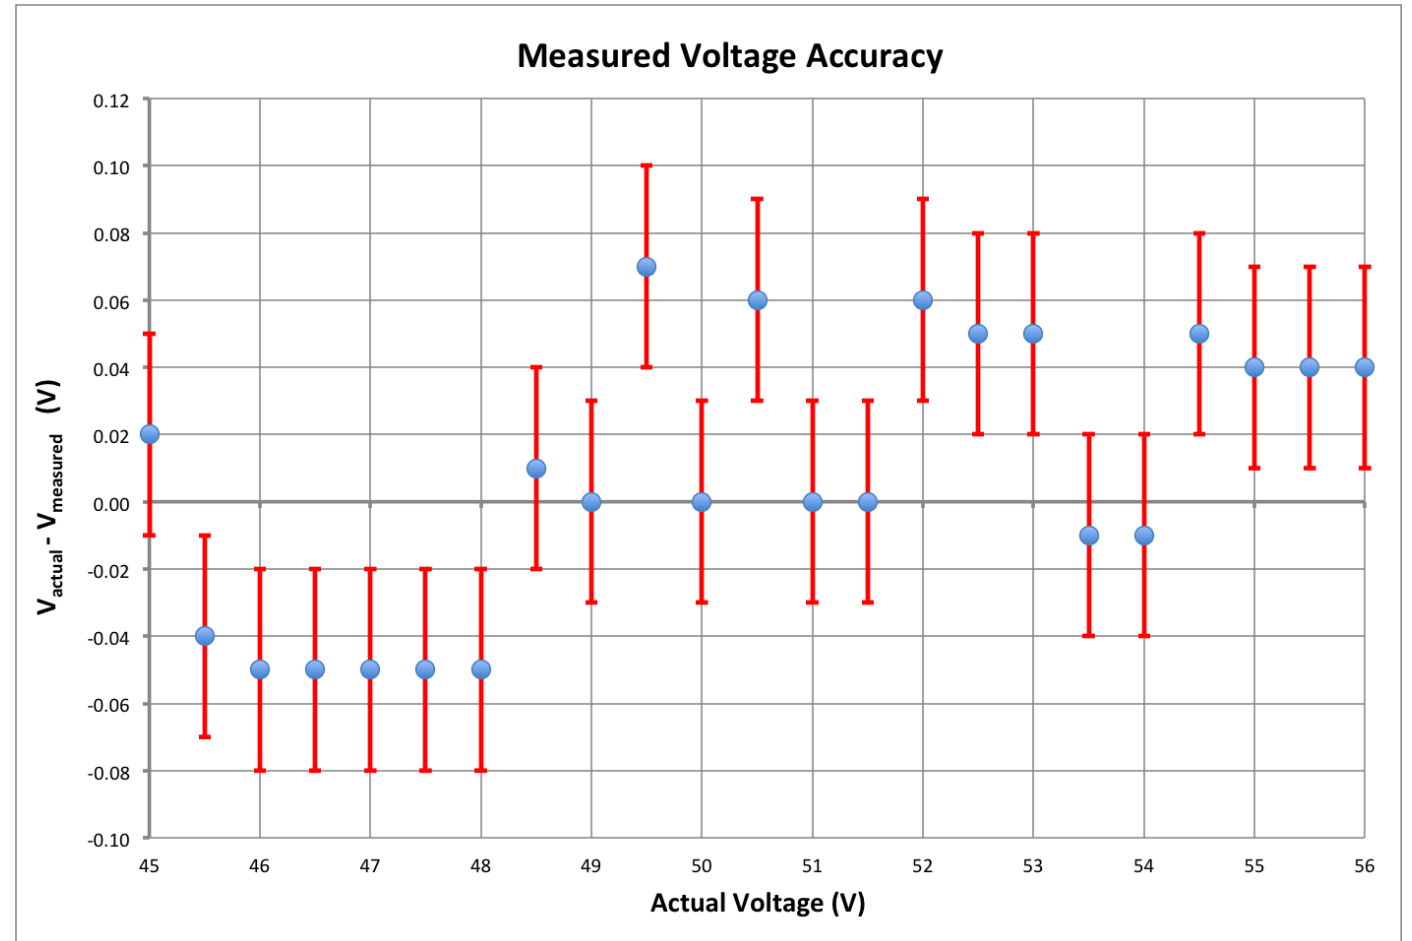
- Typical Operating Voltages at RT
 - 0% Charge: 48V*
 - 100% Charge: 52V*
- Sensor Resolution: $\pm 0.06V$
- $\Delta 1\%$ Charge : 0.04V

Figure X: Plot of the difference between the measured voltage and the actual voltage, with the error bars in red.

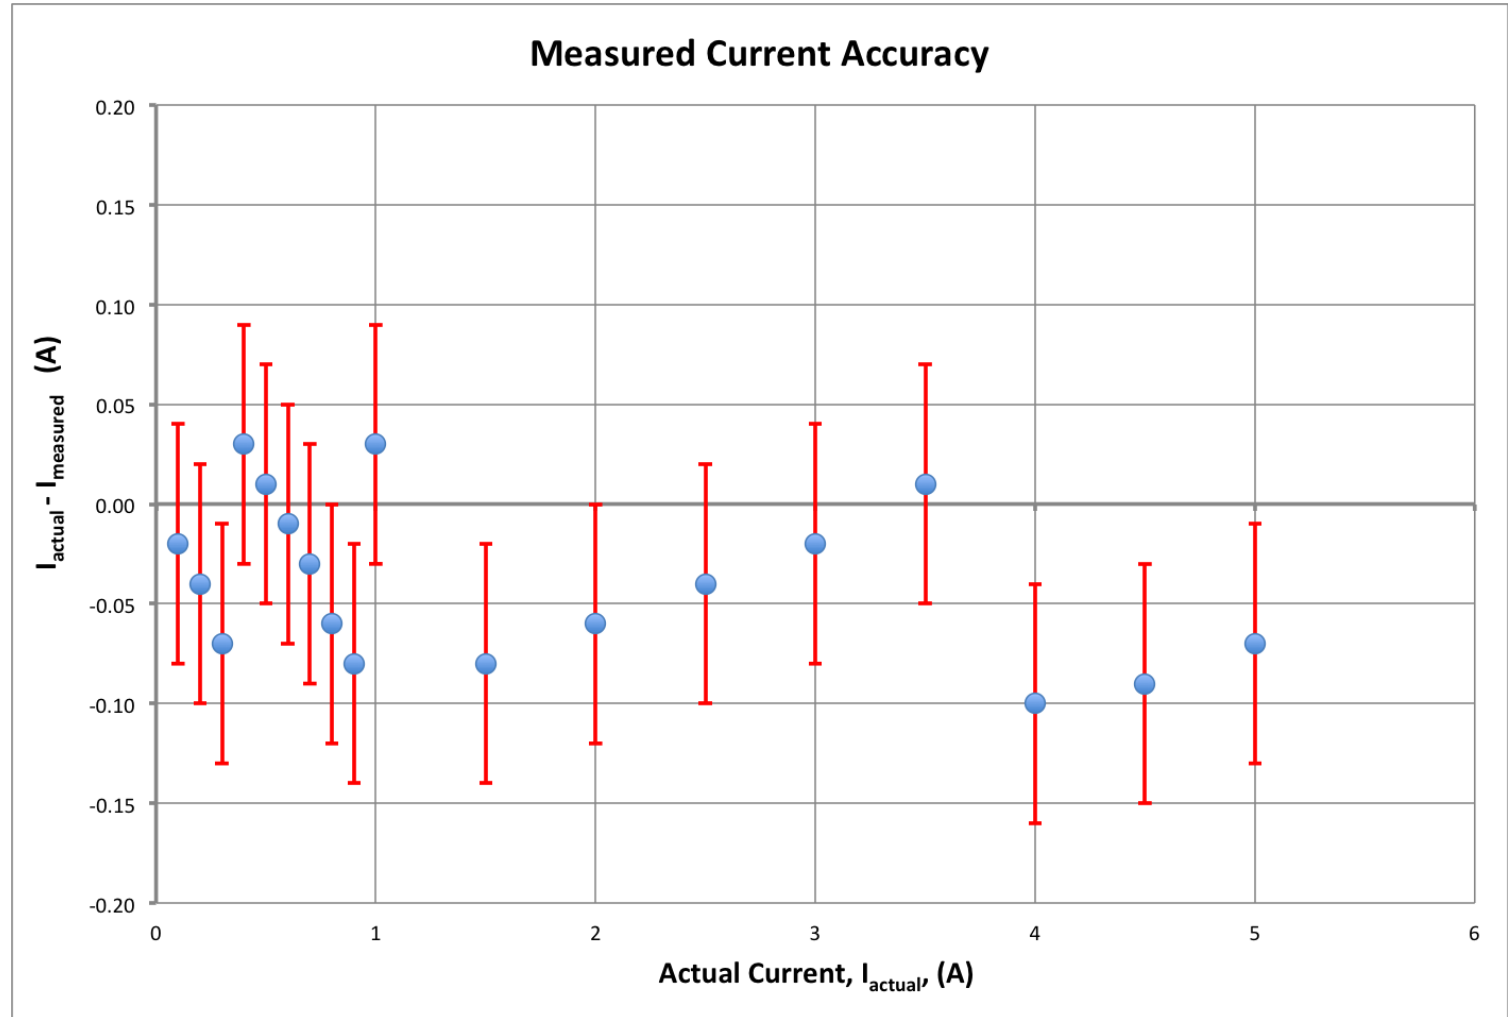
- Typical Charger Output Current
 - 3.5A - 18A
- Sensor Resolution: $\pm 0.1A$
- Additional Testing Required

Figure X: Plot of the difference between the measured current and the actual voltage, with the error bars in red.

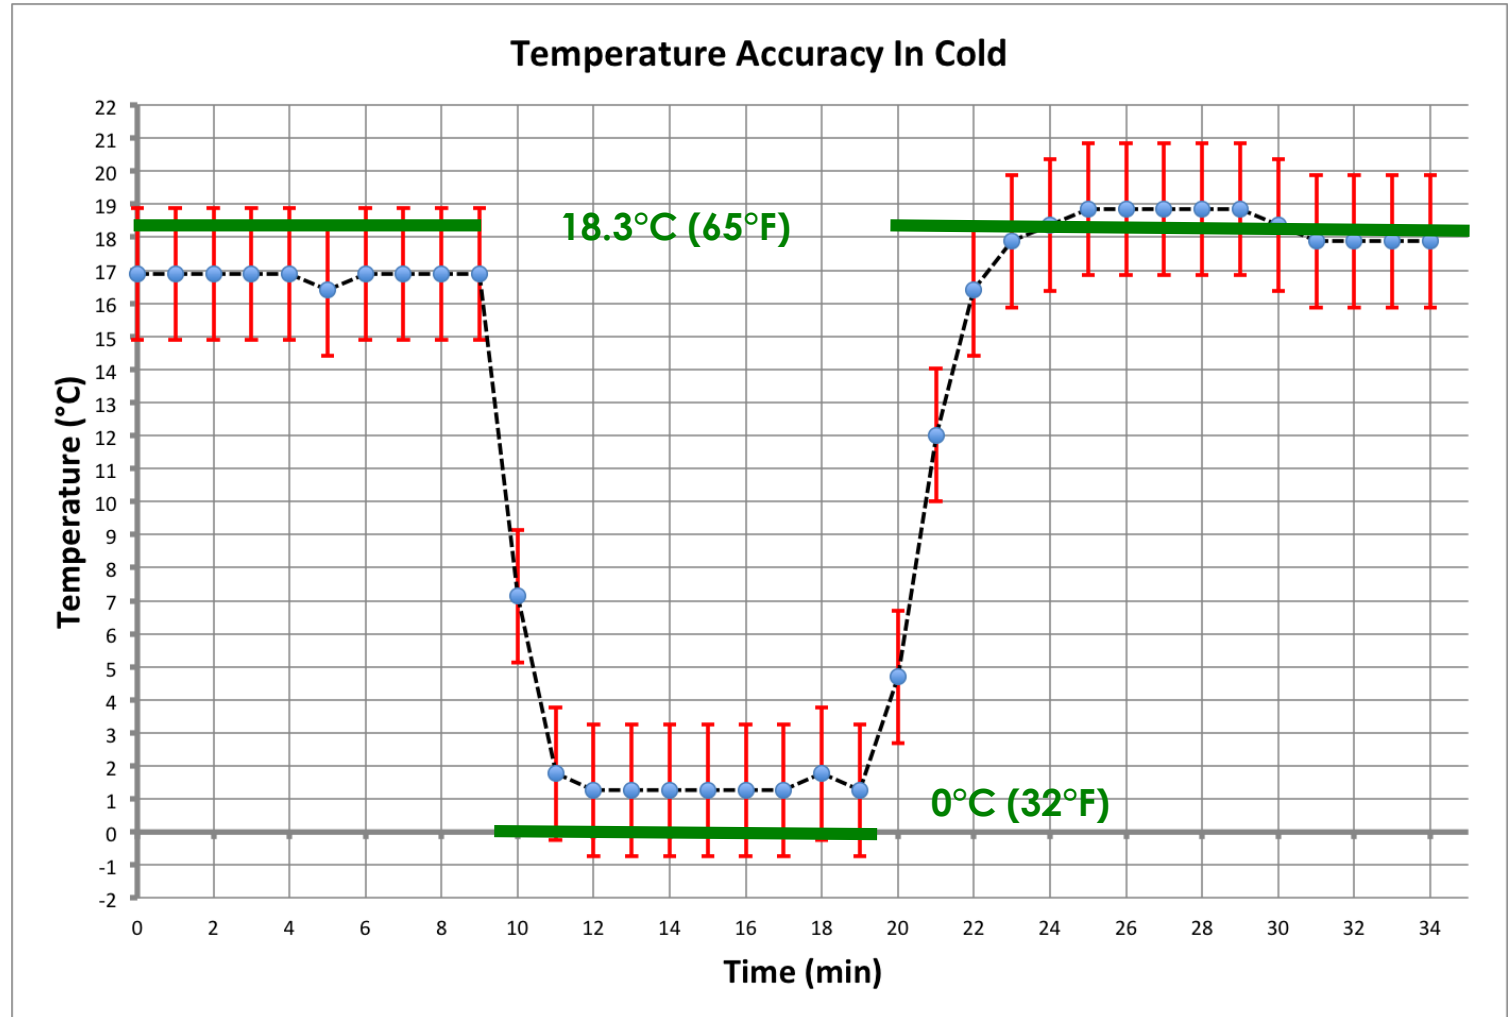
- Sensor Resolution: $\pm 2^{\circ}\text{C}$
- Slight increase in measured ambient temperature after exposed to cold.

Figure X: Plot of the measured temperature when subjected to a 0°C environment. Error bars are indicated in red.

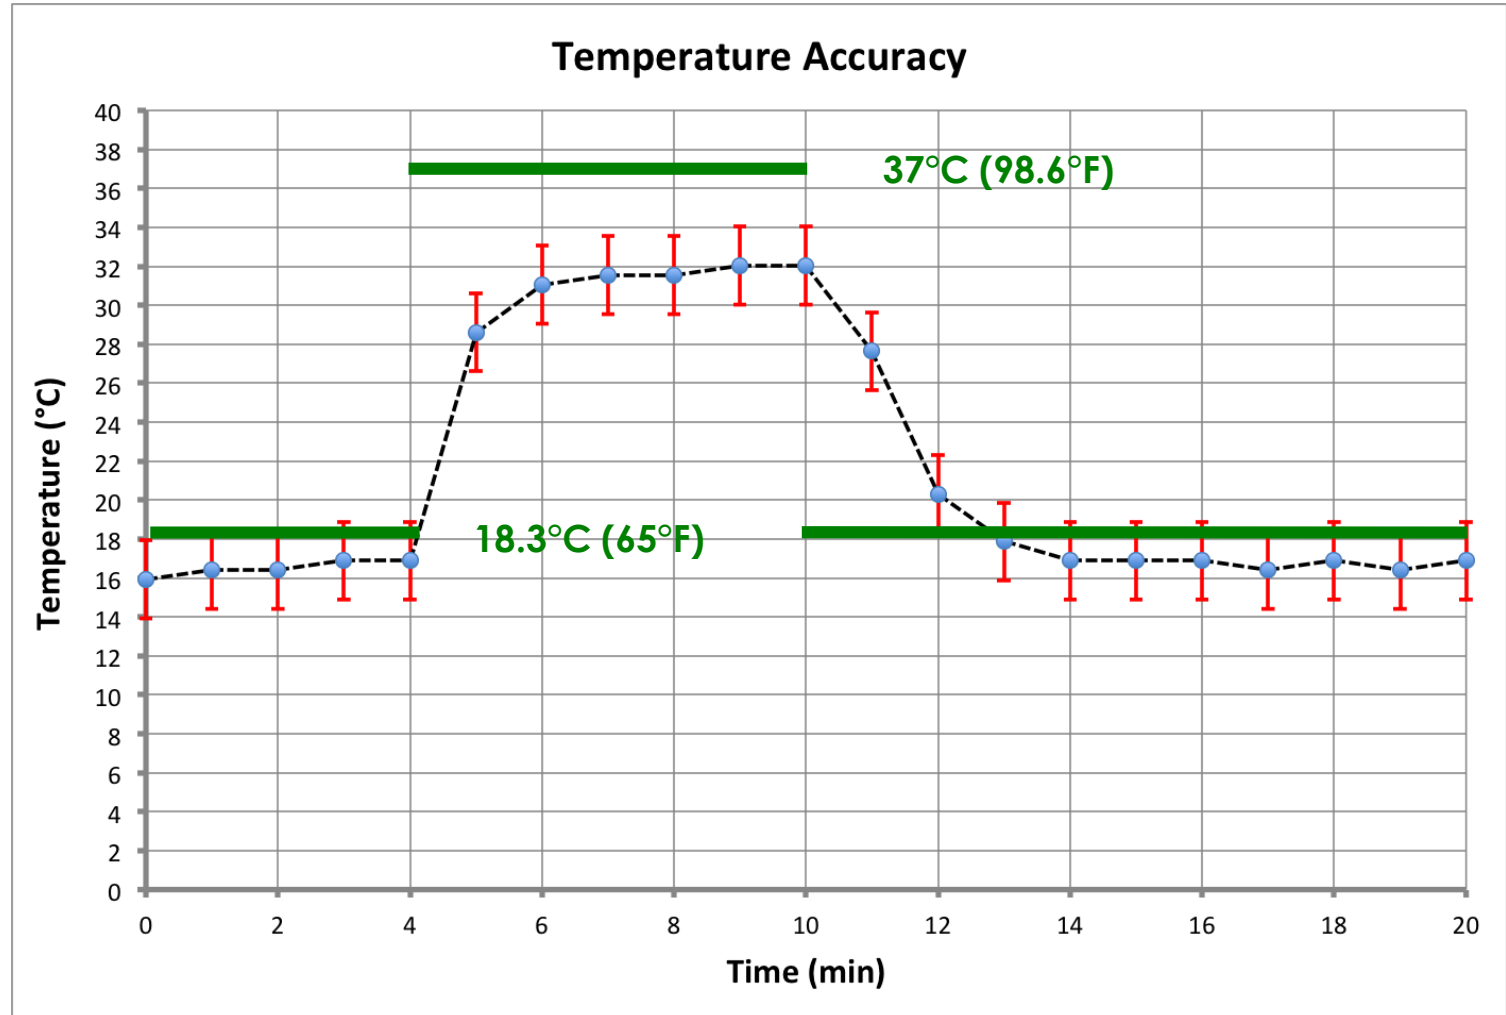
- Sensor Resolution: $\pm 2^{\circ}\text{C}$
 - Significant difference between actual and measured maximum temperature
 - Additional Testing Required
-
- This plot is temporary. I'm going to do more testing Wednesday to get a better one.

Figure X: Plot of measured temperature when placed in a 37°C environment. Error bars are indicated in red.
