Final Report
Team 5
Motor Test Rig

Danfoss Turbocor
William Sun – Representative

04/21/2017

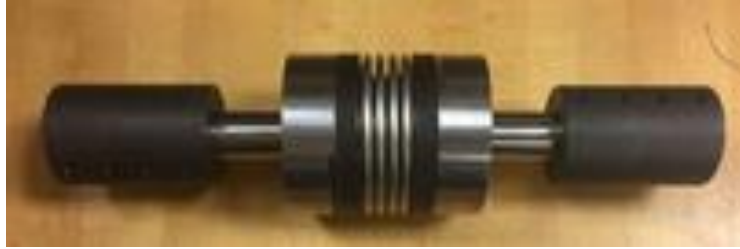
Figure 5 Last Year's Rotating Assembly

Team 4 last year assumed that only assumed that angular and parallel misalignment would play a role and axial would be minimal. They tackled the shaft misalignment by having a total of three couplers in the rotating portion of the motor test rig. They went with two rigid couplers and a bellows flexible coupler. An image of the assembled rotated assembly is seen in the figure below. Though team 4 didn't think axial misalignment played a role, it in fact had the biggest role that would impact the operation of the motor test rig. The sponsor mentioned to team 5 that since the impeller was removed, there had to be axial misalignment to be accounted for. Specifically 0.250 mm from each compressor for a total of 0.500 mm of axial misalignment before the motor test rig can be operated. The rigid coupler presented a problem with that because although it held the rotating assembly in terms of parallel and angular misalignment, there was little to no adjustment that it could have for axial misalignment. This may have been one of the reasons why team 4 last year dealt with vibrations when they started run the compressors.

Team 5 has decided to change the rotating assembly completely in order to tackle the axial misalignment issue. The amount of couplers was reduced from three to two, with both of the couplers being flexible couplers that attached to the compressors themselves. In the middle there will be a torque transducer that will act as a rigid component in the middle that will further reduce the misalignment in all three orientations.

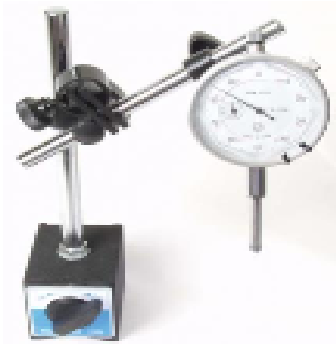
Figure 6 Dial Indicator

Team 4 from last year went with a dial alignment system in order to measure the misalignment between the motor shafts. The dial indicator system was cost effective and was purchased by the team for under \$100 with the accuracy being up to 26 μm . Dial alignment systems have a big learning curve. The operator must use his technical knowledge in using measurement tools in order to interpret the dial readings into compressor position adjustments. An image of one of the dial indicators is shown in the figure below.

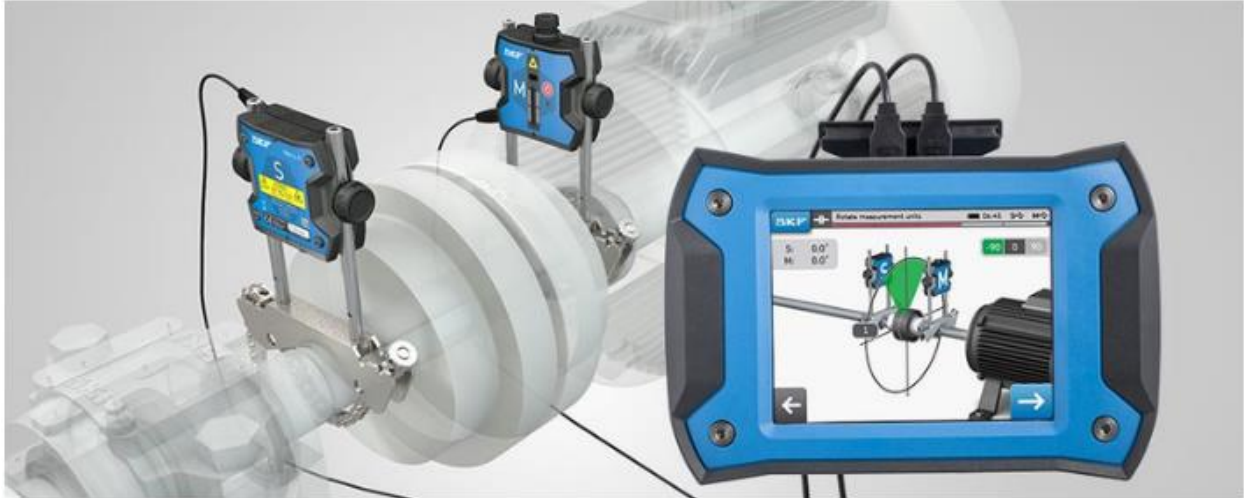
Figure 7 Laser Alignment Tool

Team 5 this year had decided to go with a laser alignment tool based on the recommendation left behind from last year's team. The laser alignment system that was selected by the team was the SKF TKSA 31 alignment tool. It has an accuracy of $\pm 5\mu\text{m}$. The total price for this comes in at \$3847.01. An image of the system can be seen in the figure below.

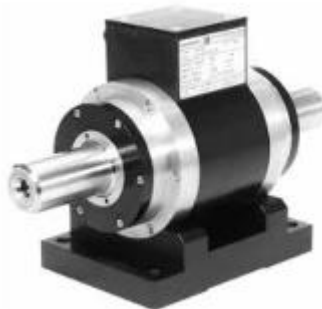
Figure 8 Magtrol TMHS 310 Torque Transducer

With further research into different types of torque transducers, a choice was made. Out of the ones that were researched, none really matched the required parameters. The transducers could match one of the parameters but not the other. Team 5 decided to go with a torque transducer that would have a high rpm limit. The transducer that was selected was the TMHS 310 that is produced by Magtrol. The specifications that it can reach was 32,000 rpm while having a nominal torque rating of 20 Nm. Though the rpm was lower than 40,000 rpm, the sponsor said that the transducer was fine choice. When the team contacted a sales representative from SKF, the team was assured that the TMHS 310 would be able to handle up to 100 Nm in range while it was in operation. An image of the transducer can be seen below.

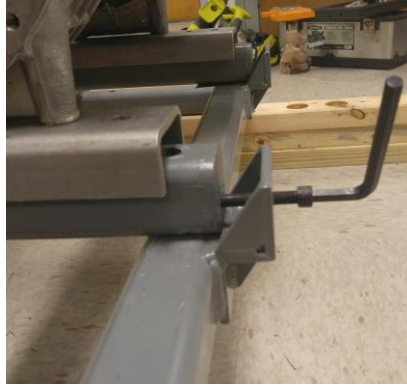
In terms of the base frame that would be needed for the two compressor to stand on, the team decided to go ahead and keep the one that was created from team 4 last year. In terms of horizontal and vertical adjustments, the team went with two methods. Shims were used to adjust the compressor vertically. In the horizontal adjustment, lateral screw sets were used in order to move the driving compressor.

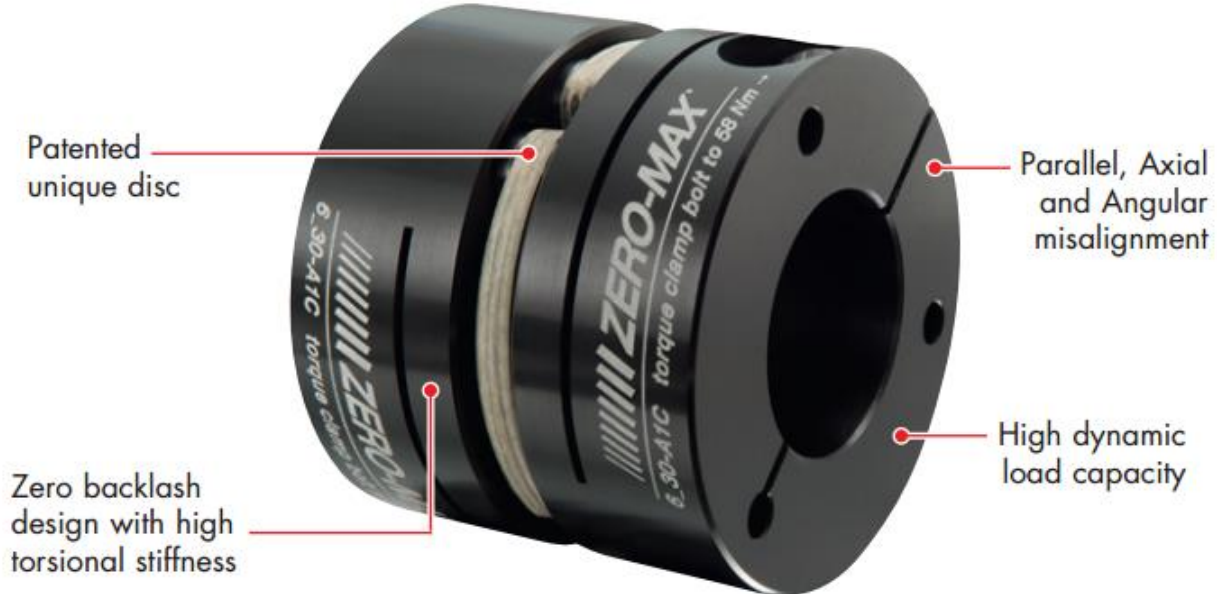
Figure 13 Zero Max Double Flex Disc Coupling

The various couplers from Zero Max offer many advantages, but the team decided to go the route of the double flex disc couplers that they produce. The couplings consist of two torsional stiff sections in combination with a unique patented disc that allows for a certain amount of misalignment and axial loads which is shown in figure 5. Out of the various options of double flex that are available from Zero Max, the team decided to go specifically with the Double Clamp A1C flex couplers. The specific model of the A1C coupler is the 6P18-A1C that can be seen in the figure below. Various factors were used in order to select this specific model. The main factor was the maximum speed that the coupler would be able to reach, which in this case is 15,000 rpm for the 6P18-A1C. The other factors that came into play was how much misalignment the coupler would allow while operating properly. The sponsor mentioned to the team that each coupler should be able to account for 0.250mm of misalignment in the axial direction for each compressor resulting in a total of 0.500mm of axial misalignment. The sponsor also mentioned that the coupler should be able to account for at least 1 degree of angular misalignment as well. Based on those factors, the 6P18-A1C was chosen because of the fact that it can account for 2 degrees of angular, 0.44mm of parallel, and 1.6mm of axial misalignment. The other models had a higher accountability for misalignment, but the one that was chosen had the highest maximum speed that be able to reach the goal that was set by the sponsor for the team this year.

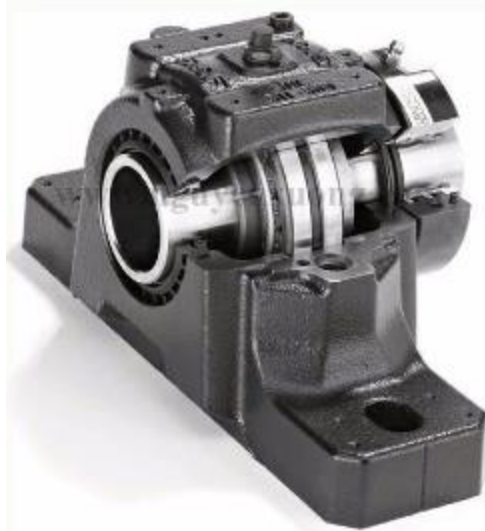
Figure 14 Bearing Housing SNL 505

Due to the fact that our torque transducer was not approved for purchase, the team was inclined to test their theory using a mock transducer. In order to mimic the transducer in the system, a rigid component was needed to hold the shaft. They selected the following bearing and housing kit shown below.

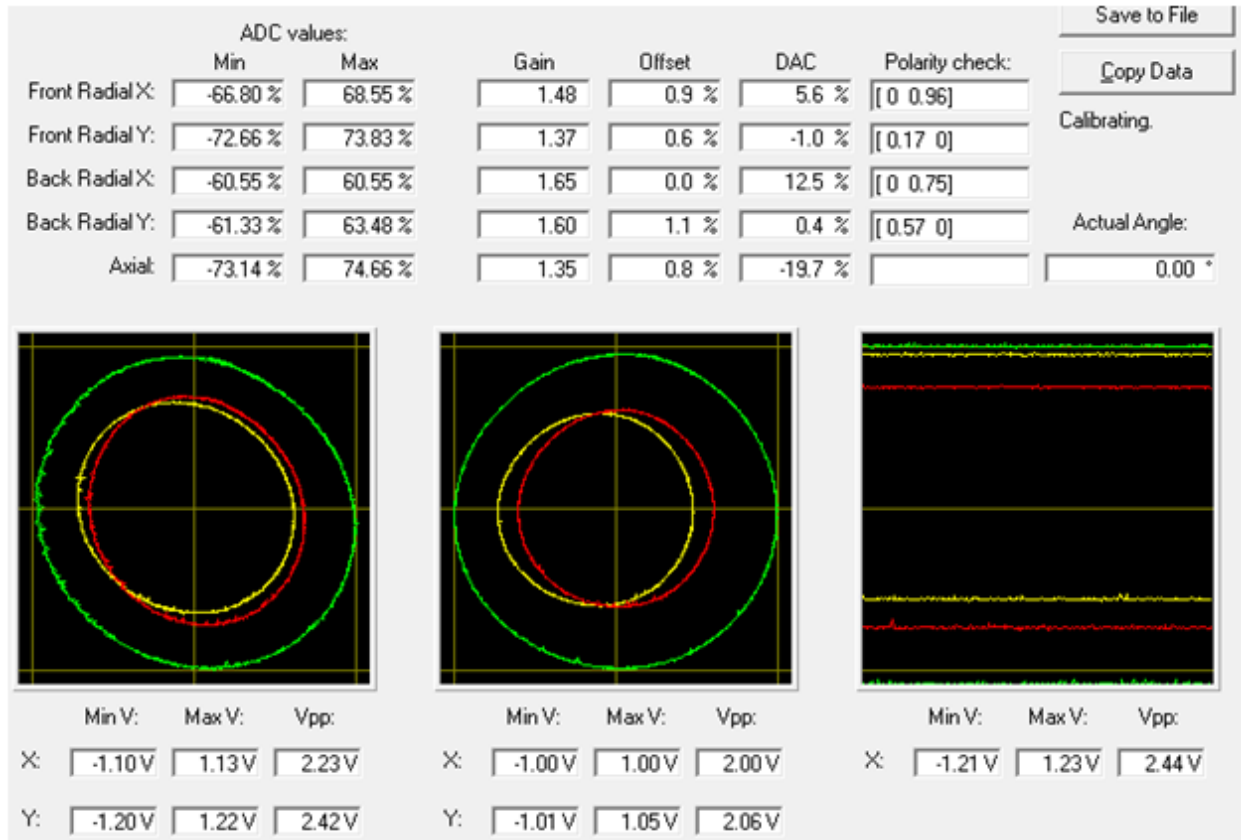
Figure 17 Initial test with no coupling

This was the base run of the compressor, showing the front and rear bearings with the circles to represent the concentricity between the front and rear bearings. As expected, without anything attached to the shaft it has no issue levitating and no noise that affects the natural frequency of the system.

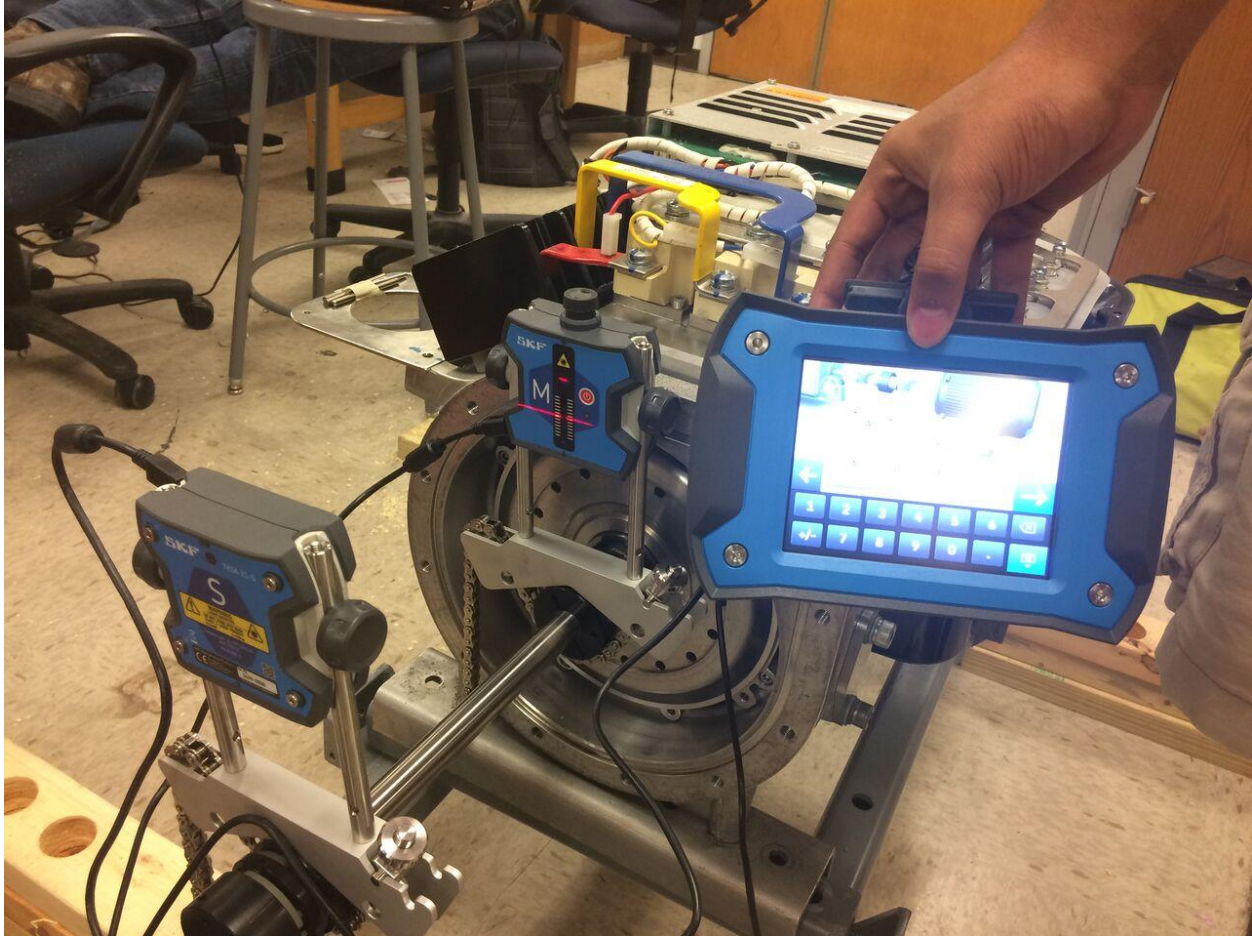
Figure 26 Alignment tool operation

Now that the actual lifting and moving of the compressor is accounted for, the tool to determine the alignment was the next most important thing. Last year they chose to use a hand dial alignment tool because it is relatively inexpensive and if used correctly can be very accurate. However, this has the issue of some human error based on the angle you are reading the dial from, as well as the fact that it is time consuming to adjust the compressor slightly and then take 3 readings again over and over until it's close enough for safety. This year the team purchased a laser alignment tool, the TKSA 31. It takes 3 readings at 3 o'clock, 9 o'clock, and 12 o'clock

relative to your centerline and creates a plane to determine the offset between the two tools as shown below. After it takes these readings it actually can show you in real time where you need to adjust more or less depending on which compressor you choose to be the “stationary reference” and the other one will be the one that’s adjusted. It is a faster and more precise tool that eliminates majority of human error as long as it is set up according to the manual.
